LANDSLIDES AND RELATED FEATURES

OF THE SALTSBURGO, PA. QUADRANGLE

by
John S. Pomeroy
1979

U.S. Geological Survey
OPEN FILE MAP 79-1314 (0-5)

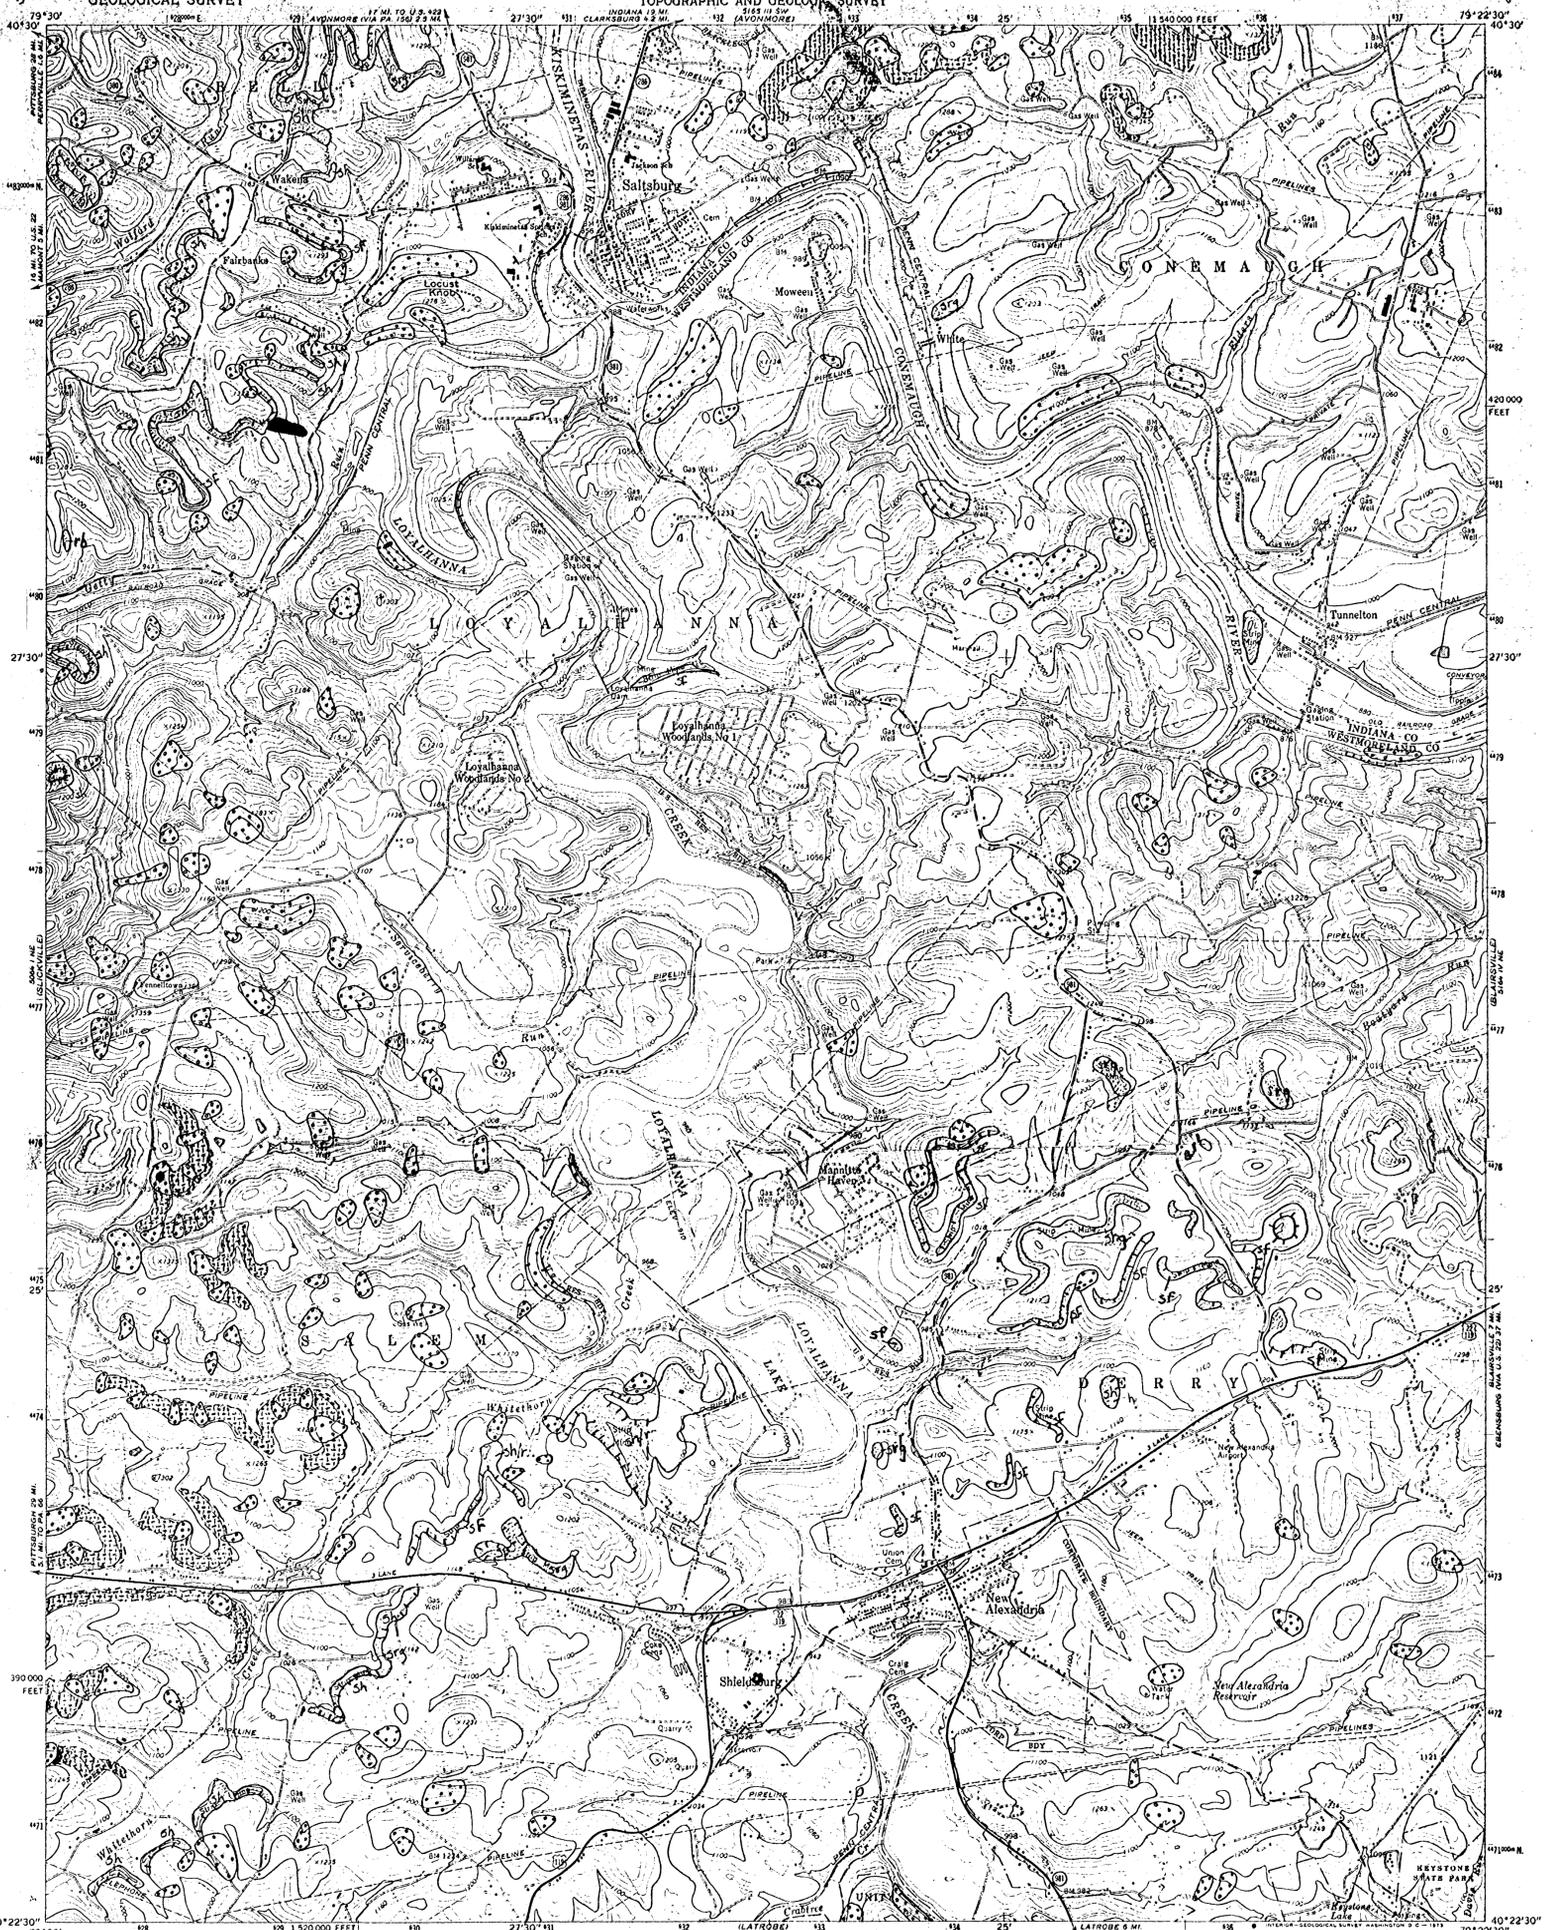
Landslides and related features interpreted
from aerial photographs:
1:40,000 (black and white) 1974

Photointerpretation and field check 1976
This map has not been edited or reviewed
for conformity with Geological Survey
standards and nomenclature.

- ACTIVE OR RECENTLY ACTIVE LANDSLIDE**
Complex landslide composed of earthflow, debris
slide, earth and rock slump. Identified from
historical records, and from scars, debris and
other field evidence. Ground extremely unstable;
sliding accelerated by excavation, loading and
changes in drainage conditions. May include
areas with several active slides too small to
be shown separately. Questioned where doubtful.

- OLD LANDSLIDE**
Area of extensive hummocky ground caused by
earthflow and earth and rock slump. Lacks
clear evidence of active sliding. Relatively
stable in natural, undisturbed state,
generally not affected by small structures properly
sited in areas away from the edge of the toe;
can be reactivated by extensive, rapid excava-
tion, loading, and changes in ground water and
surface water conditions. Area of old landslide
probably includes recent ones not identified
from field evidence or otherwise documented.
Upslope boundary of landslide generally defined
by modified scarp, but downslope (toe) may be
gradational and not well defined. Questioned
where doubtful.

- COMBINATION LANDSLIDE**
Area of recent and old slides in which
individual slides are not identified.
- COLLUVIAL SLOPE**
Valley wall along major streams with slope as
steep as 40° (85%); stony, clayey silt soil up
to 50 ft. (15 m) thick; commonly buttressed by
a terrace or bench at the toe of the slope; very
susceptible to sliding by cutting of toe area,
removal of terrace or bench, and overloading;
slide commonly activated without apparent cause.

- SCREE**
Residual accumulations of coarse rock material
lying on quartzite slopes of the Valley and
Ridge province. Generally stable except where
subjected to extreme rainfall.

- COLLUVIAL SLOPES WITH LANDSLIDES**
Landslides too small or obscure to map
individually.
- AREAS SUSCEPTIBLE TO DEBRIS FLOWS AND DEBRIS
AVALANCHES**
Primarily shallow, narrow ravines and chutes with
accumulation of stony colluvium generally 10 ft.
(3 m) or less in thickness; susceptible to rapid
movement during intense rainfall. Most ravines
and chutes designated show evidence of former
debris flows and avalanches. Symbol & desig-
nates historical debris flow or debris avalanche.

- AREAS SUSCEPTIBLE TO ROCKFALL**
Steep, locally vertical, natural and man-made
slopes and cliffs, 15 ft. (4.5 m) or more high;
formed dominantly of sandstone, limestone, sandy
shale, mudstone and claystone. Interbedded mud-
stone, claystone and shale weather rapidly leaving
sandstone and limestone rock faces unsupported.

- SOIL AND ROCK SUSCEPTIBLE TO LANDSLIDING**
Soil and rock similar to that involved in land-
slides elsewhere in map area; primarily areas
underlain by claystone, mudstone and shale
associated with other rock types. Rock weathers
rapidly on exposure forming clayey soil highly
susceptible to sliding. Includes covers (U-shaped,
shallow valleys) containing thick layers of clayey
soil that are very susceptible to sliding where
excavation breaks continuity of slope and where
overloaded by artificial fill.

- AREAS LEAST PRONE TO LANDSLIDES**
Map areas in which no patterns or symbols are shown;
primarily valley floors, ridge tops and broad
benches; modification by excavation and fill may
lead to local landslides.
Includes slopes where landslides are sparse.
