LANDSLIDES AND RELATED FEATURES

OF THE WHARTON, PA QUADRANGLE

by
John S. Pomeroy
1981

U.S. Geological Survey
OPEN FILE MAP 81-238 (E-16)

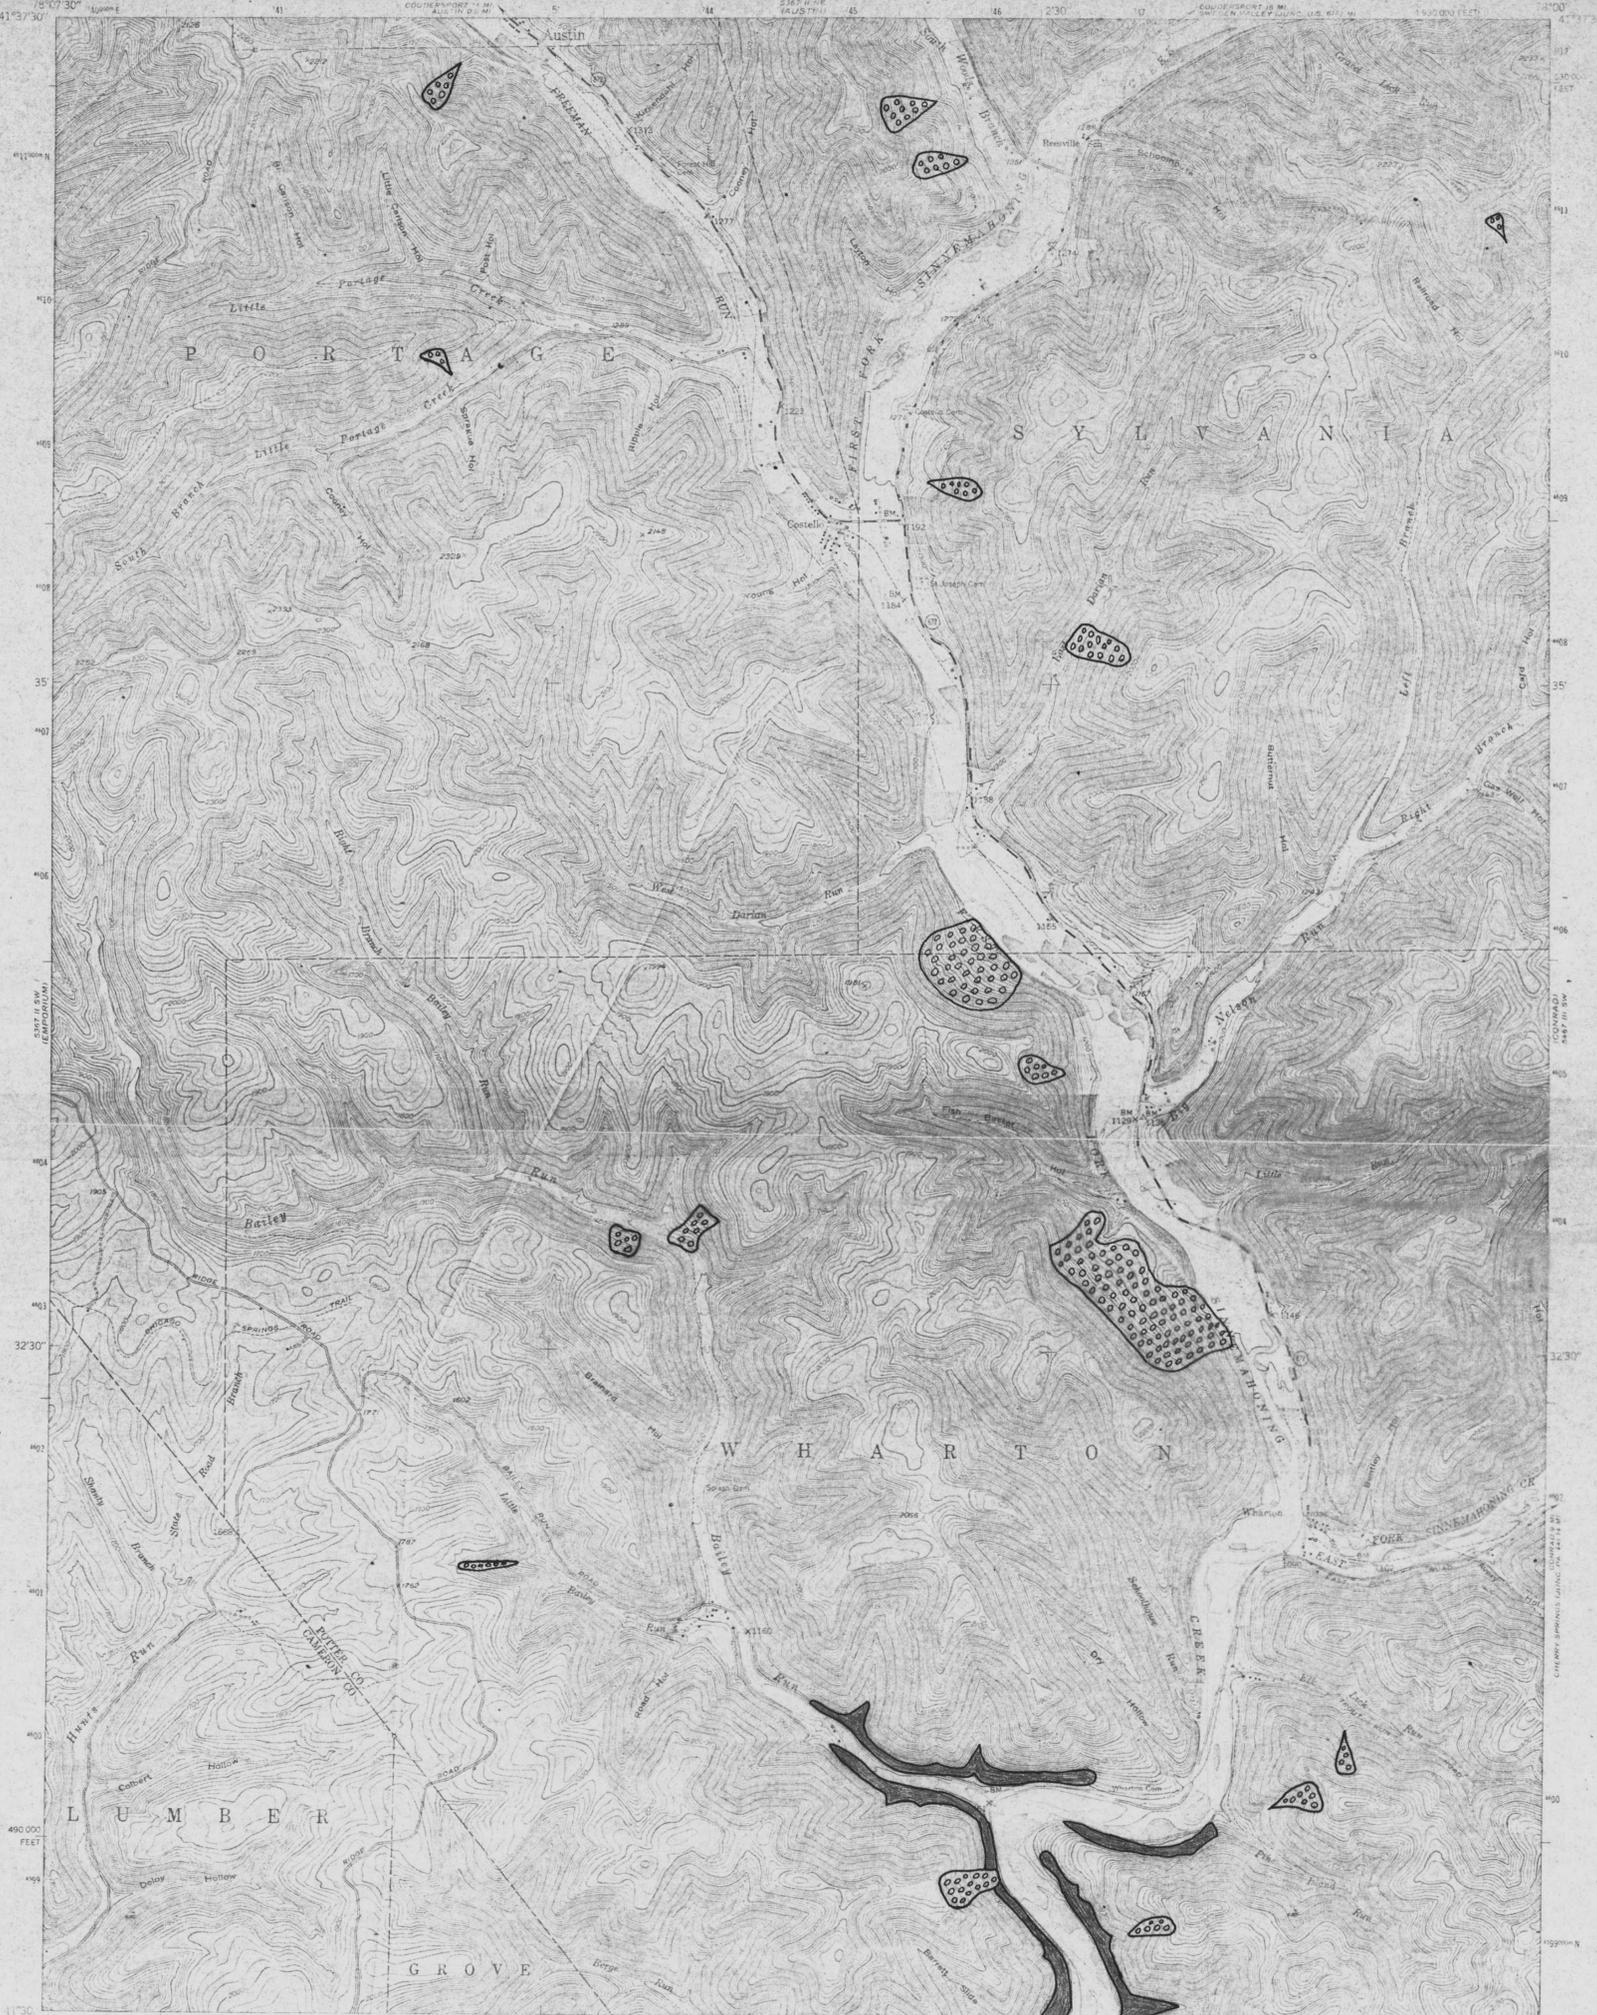
Landslides and related features interpreted
from aerial-photographs:
1:78,000 (black and white) 1977
Photointerpretation and field check 1978-1979
This map has not been edited or reviewed
for conformity with Geological Survey
standards and nomenclature.

ACTIVE OR RECENTLY ACTIVE LANDSLIDE
 Complex landslide composed of earthflow, debris
slide, earth and rock slump. Identified from
historical records, and from scars, debris and
other field evidence. Ground extremely unstable;
sliding accelerated by excavation, loading and
changes in drainage conditions. May include
areas with several active slides too small to
be shown separately. Questioned where doubtful.
May be shown with symbol (A) where difficult to discern.

OLD LANDSLIDE
 Area of extensive hummocky ground caused by
earthflow and earth and rock slump. Lacks
clear evidence of active sliding. Relatively
stable in natural, undisturbed state,
generally not affected by small structures properly
sited in areas away from the edge of the toe;
can be reactivated by extensive, rapid excavation,
loading, and changes in ground water and
surface water conditions. Area of old landslide
probably includes recent ones not identified
from field evidence or otherwise documented.
Upslope boundary of landslide generally defined
by modified scarp, but downslope (toe) may be
gradational and not well defined. Questioned
where doubtful.

COLLUVIAL SLOPE
 Valley wall along major streams with slope as
steep as 40° (85%); stony, clayey silt soil up
to 50 ft. (15 m) thick; commonly buttressed by
a terrace or bench at the toe of the slope; very
susceptible to sliding by cutting of toe area,
removal of terrace or bench, and overloading;
slide commonly activated without apparent cause.

**AREAS SUSCEPTIBLE TO DEBRIS FLOWS AND DEBRIS
AVALANCHES**
 Primarily shallow, narrow ravines and chutes with
accumulation of stony colluvium generally 10 ft.
(3 m) or less in thickness; susceptible to rapid
movement during intense rainfall. Most ravines
and chutes designated show evidence of former
debris flows and avalanches. Symbol (A) designates
historical debris flow or debris avalanche.

AREAS SUSCEPTIBLE TO ROCKFALL
 Steep, locally vertical, natural and man-made
slopes and cliffs, 15 ft. (4.5 m) or more high;
formed dominantly of sandstone, limestone, sandy
shale, mudstone and claystone. Interbedded mud-
stone, claystone and shale weather rapidly leaving
sandstone and limestone rock faces unsupported.

SOIL AND ROCK SUSCEPTIBLE TO LANDSLIDING
 Soil and rock similar to that involved in land-
slides elsewhere in map area; primarily areas
underlain by claystone, mudstone and shale
associated with other rock types. Rock weathers
rapidly on exposure forming clayey soil highly
susceptible to sliding. Includes coves (U-shaped,
shallow valleys) containing thick layers of clayey
soil that are very susceptible to sliding where
excavation breaks continuity of slope and where
overloaded by artificial fill.

AREAS LEAST PRONE TO LANDSLIDES
 Map areas in which no patterns or symbols are shown;
primarily valley floors, ridge tops and broad
benches; modification by excavation and fill may
lead to local landslides.
Includes slopes where landslides are sparse.
