OFMI 16-01.0, Plate 2
**Water Depth of
 Mud Lick/Killbuck
 Glendale Lake**
 Prince Gallitzin State Park,
 Cambria County, Pennsylvania
visitPAparks.com

Contour interval is 5 feet.
 Bathymetric data collected September 21 to 23, 2015 by R. Behr and M. Moore, Bureau of Topographic and Geologic Survey.
 Data processing and map compilation by R. Behr. Base map is 2010 NAIP orthophotography.
 Depths based on a normal pool elevation of 1427 feet.
 January 2016

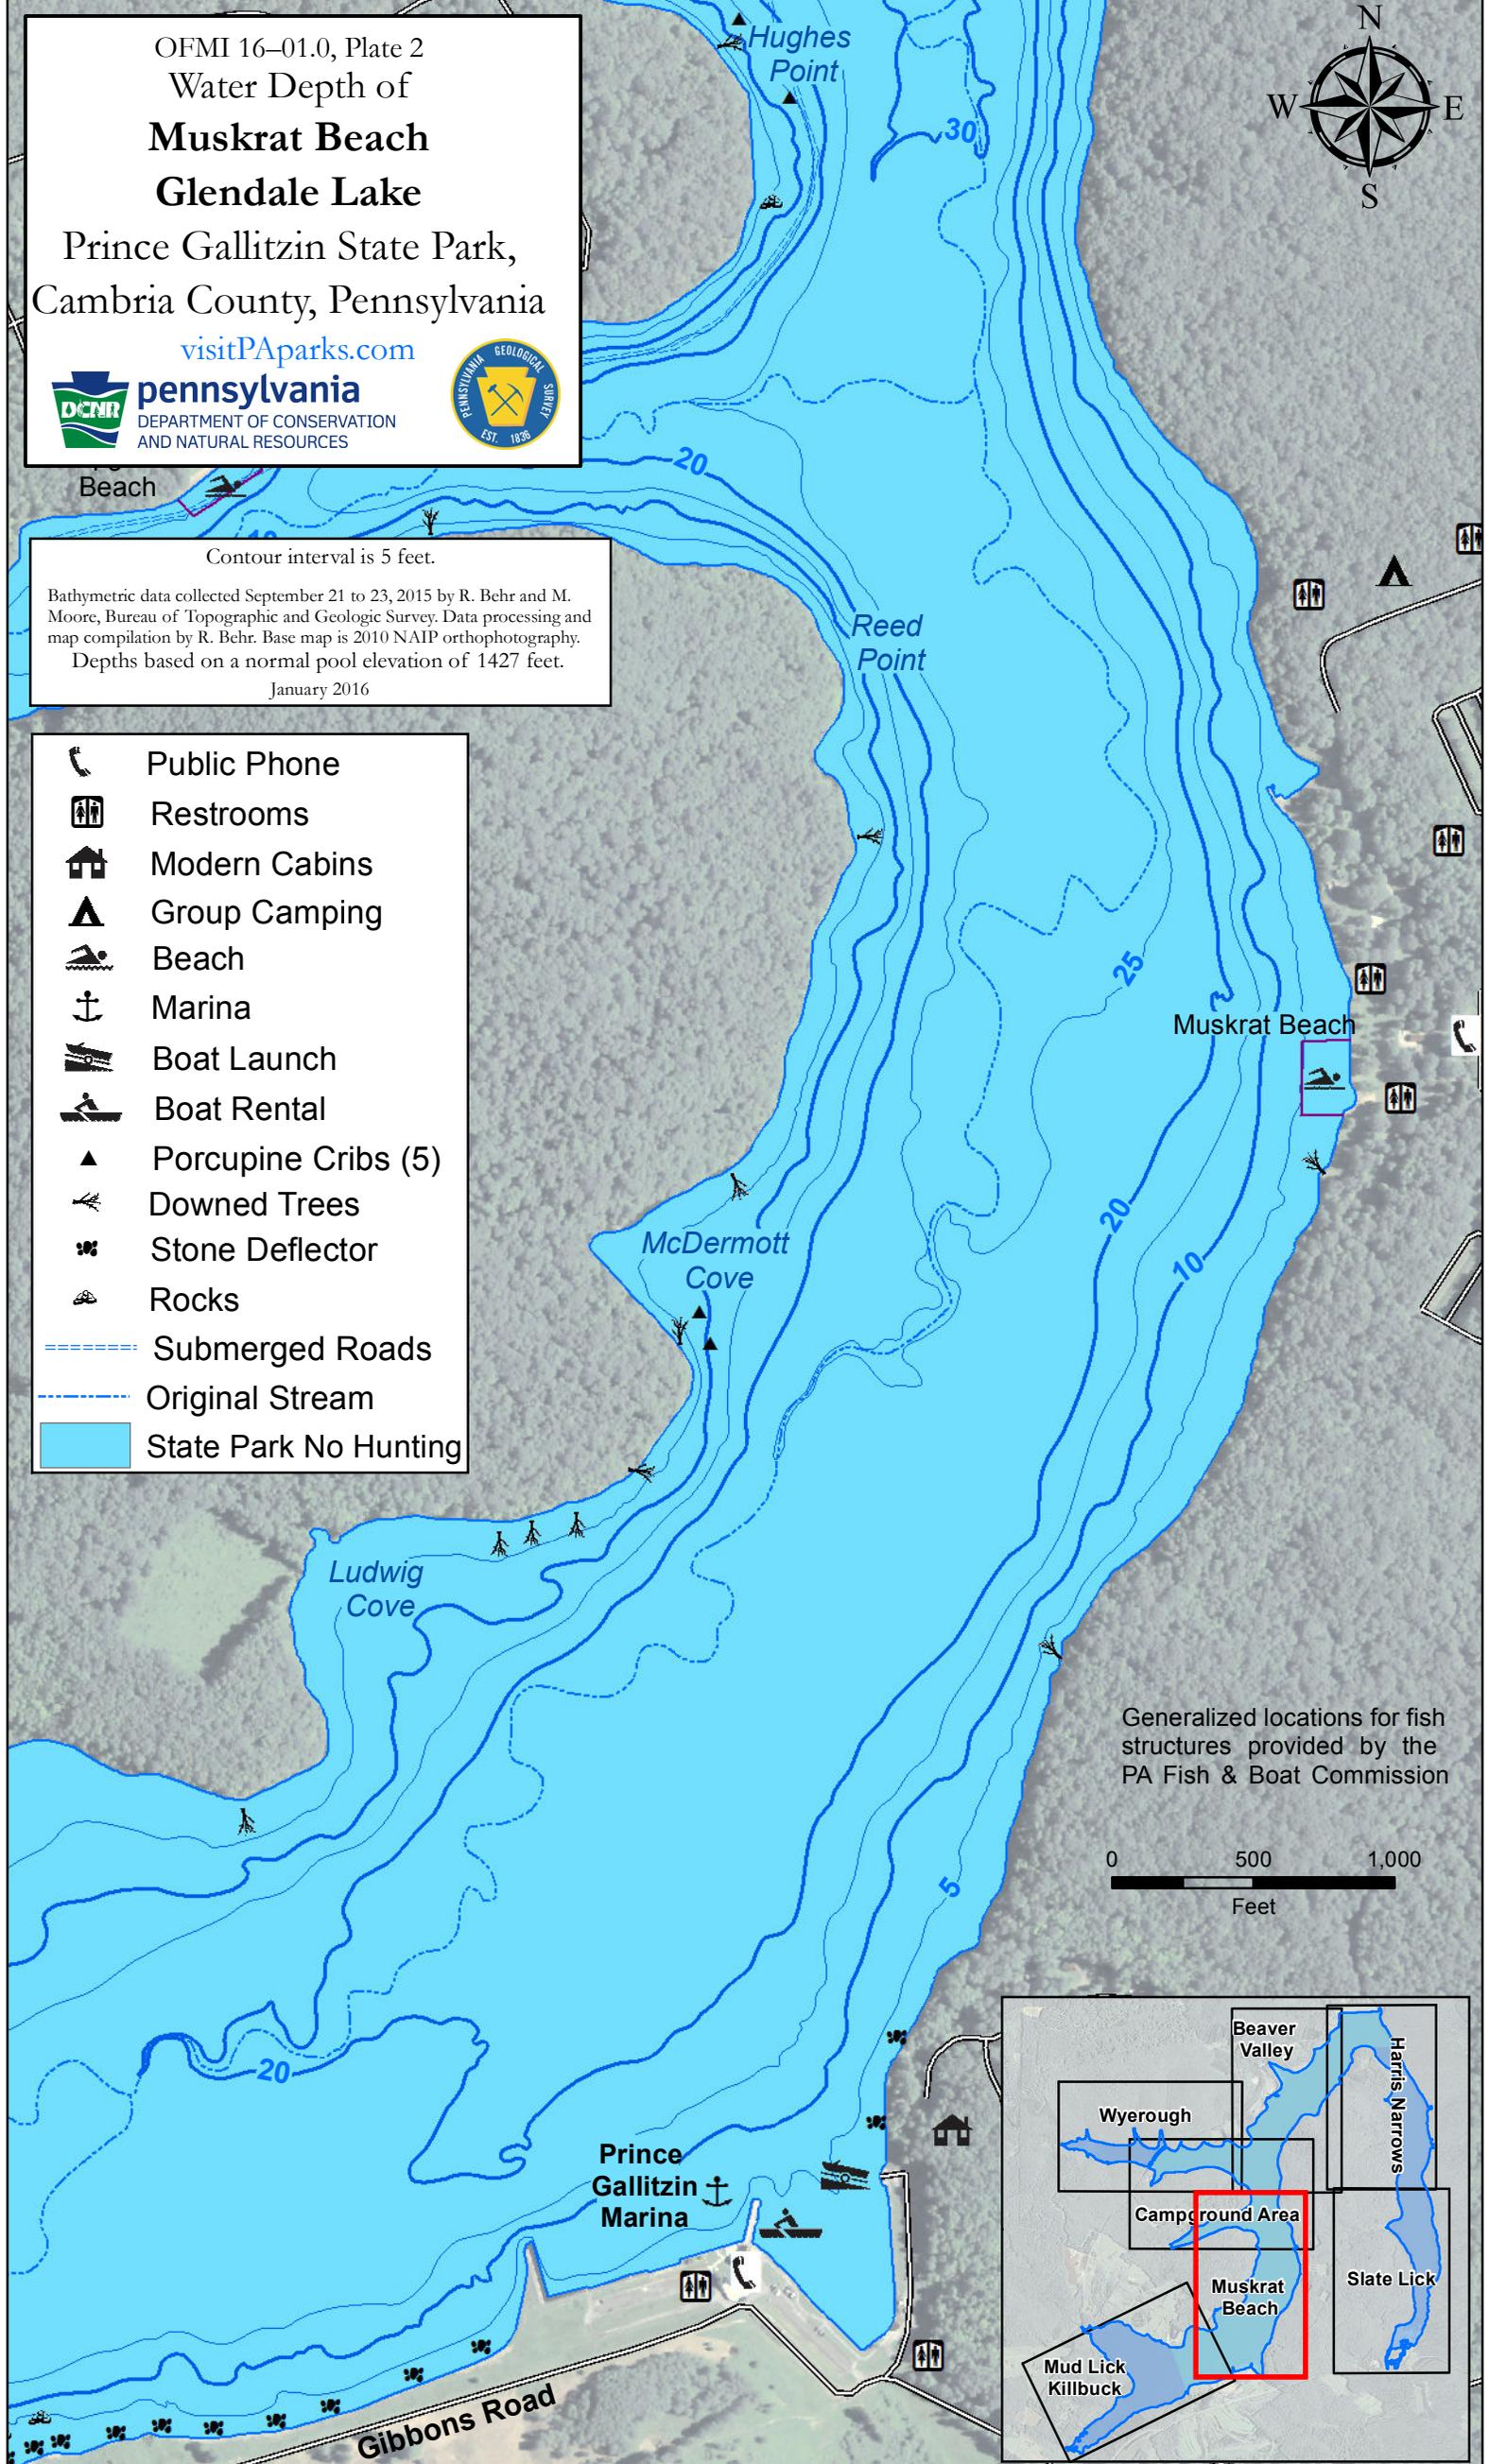
Water Depth of Muskrat Beach Glendale Lake

Bathymetric data collected September 21 to 23, 2015 by R. Behr and M. Moore, Bureau of Topographic and Geologic Survey. Data processing and map compilation by R. Behr. Base map is 2010 NAIP orthophotography. Depths based on a normal pool elevation of 1427 feet.

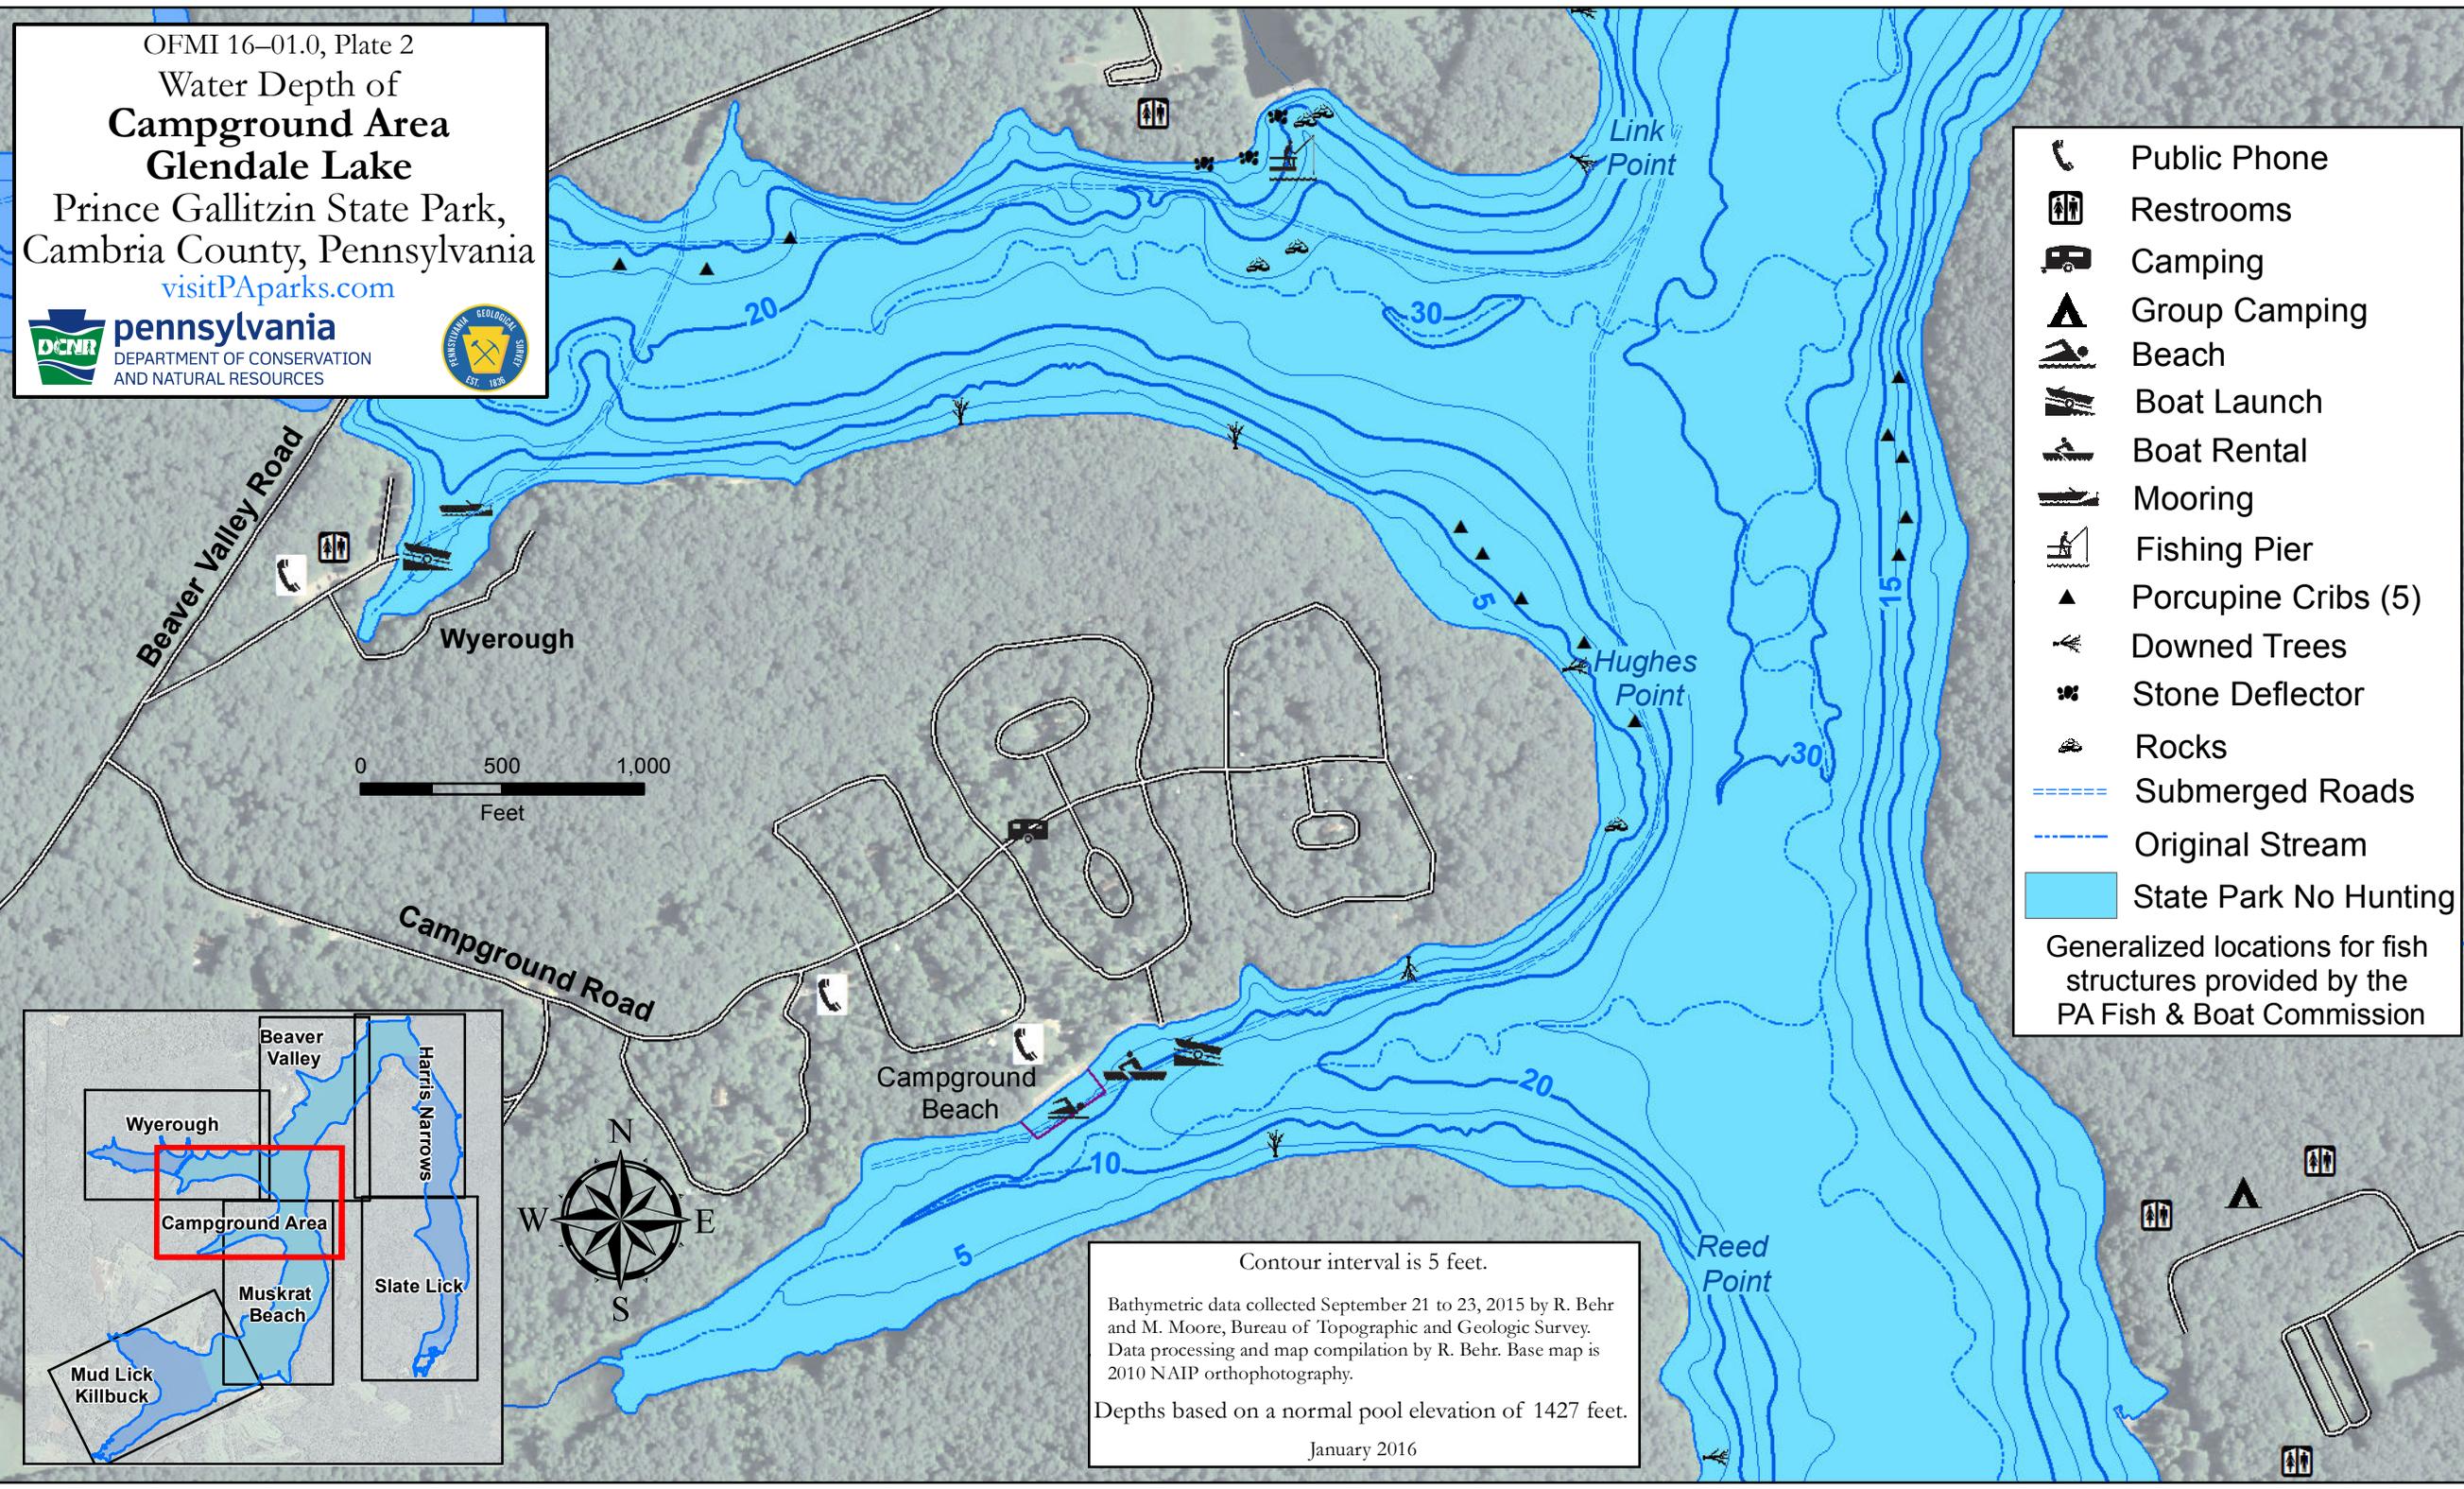
OFMI 16-01.0, Plate 2
**Water Depth of
 Campground Area
 Glendale Lake**

Contour interval is 5 feet.
 Bathymetric data collected September 21 to 23, 2015 by R. Behr and M. Moore, Bureau of Topographic and Geologic Survey. Data processing and map compilation by R. Behr. Base map is 2010 NAIP orthophotography.
 Depths based on a normal pool elevation of 1427 feet.
 January 2016

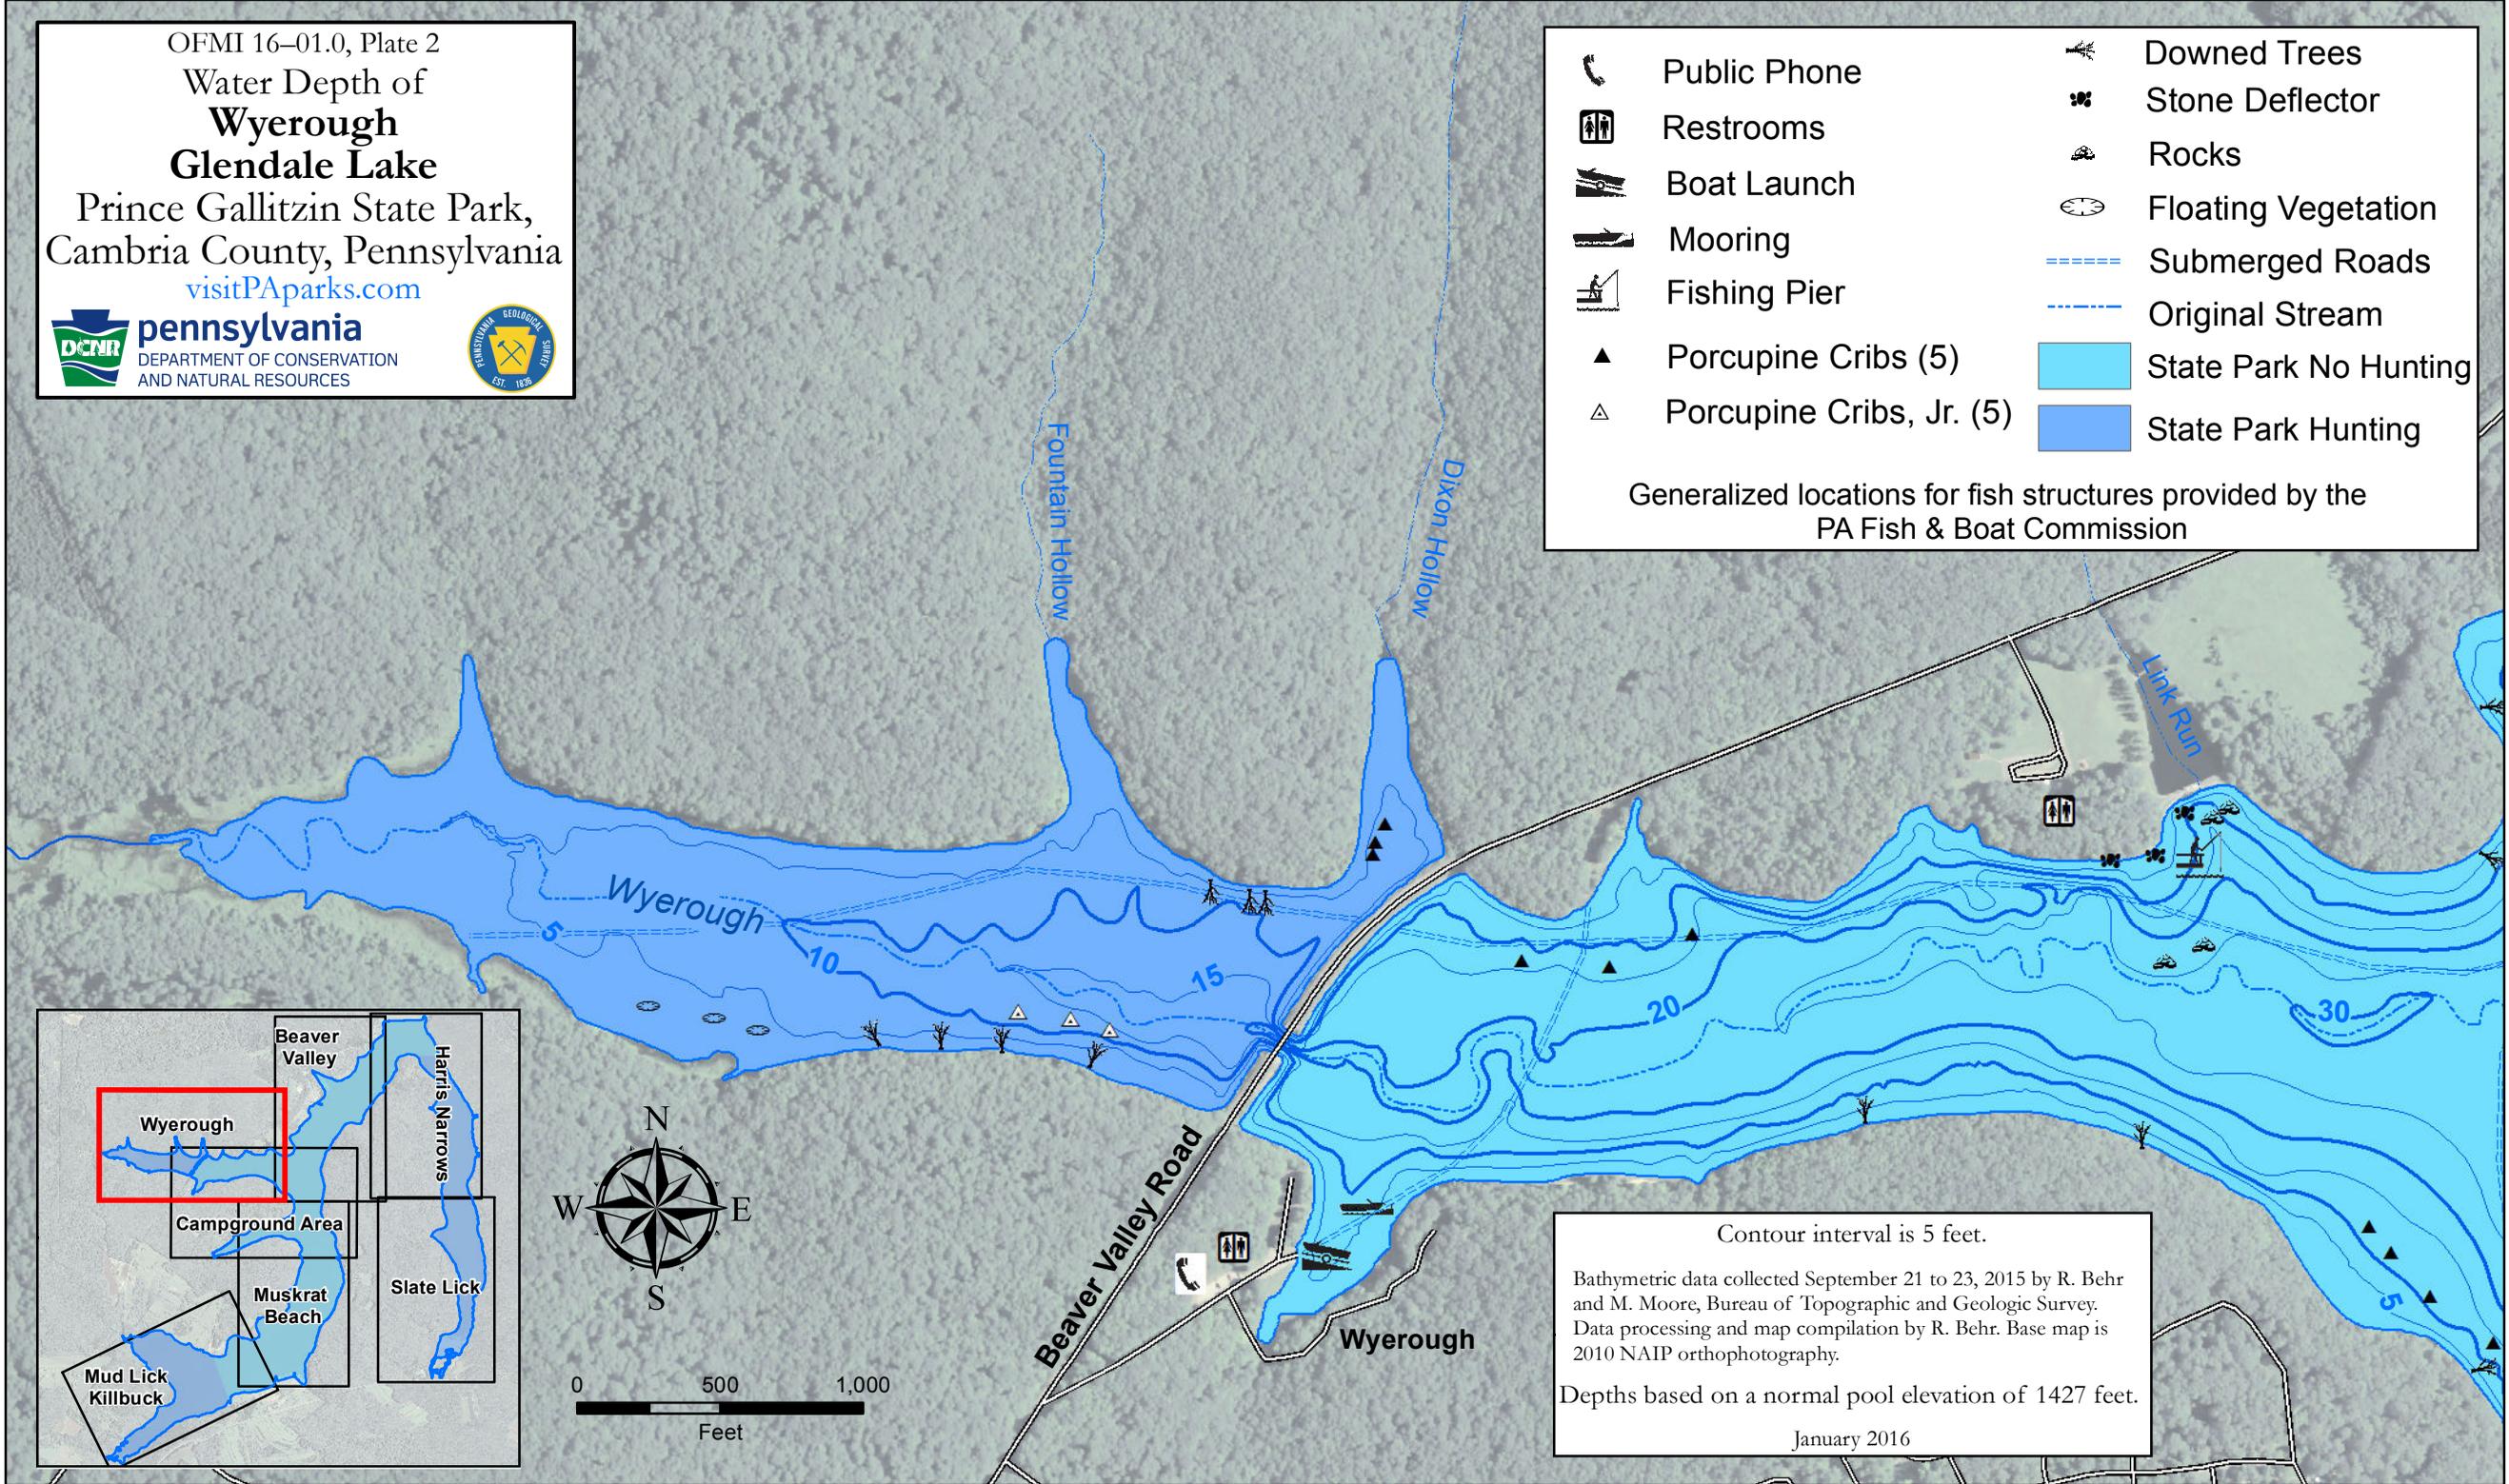
OFMI 16-01.0, Plate 2
**Water Depth of
 Wyerough
 Glendale Lake**
 Prince Gallitzin State Park,
 Cambria County, Pennsylvania
visitPAparks.com

Contour interval is 5 feet.
 Bathymetric data collected September 21 to 23, 2015 by R. Behr and M. Moore, Bureau of Topographic and Geologic Survey.
 Data processing and map compilation by R. Behr. Base map is 2010 NAIP orthophotography.
 Depths based on a normal pool elevation of 1427 feet.
 January 2016

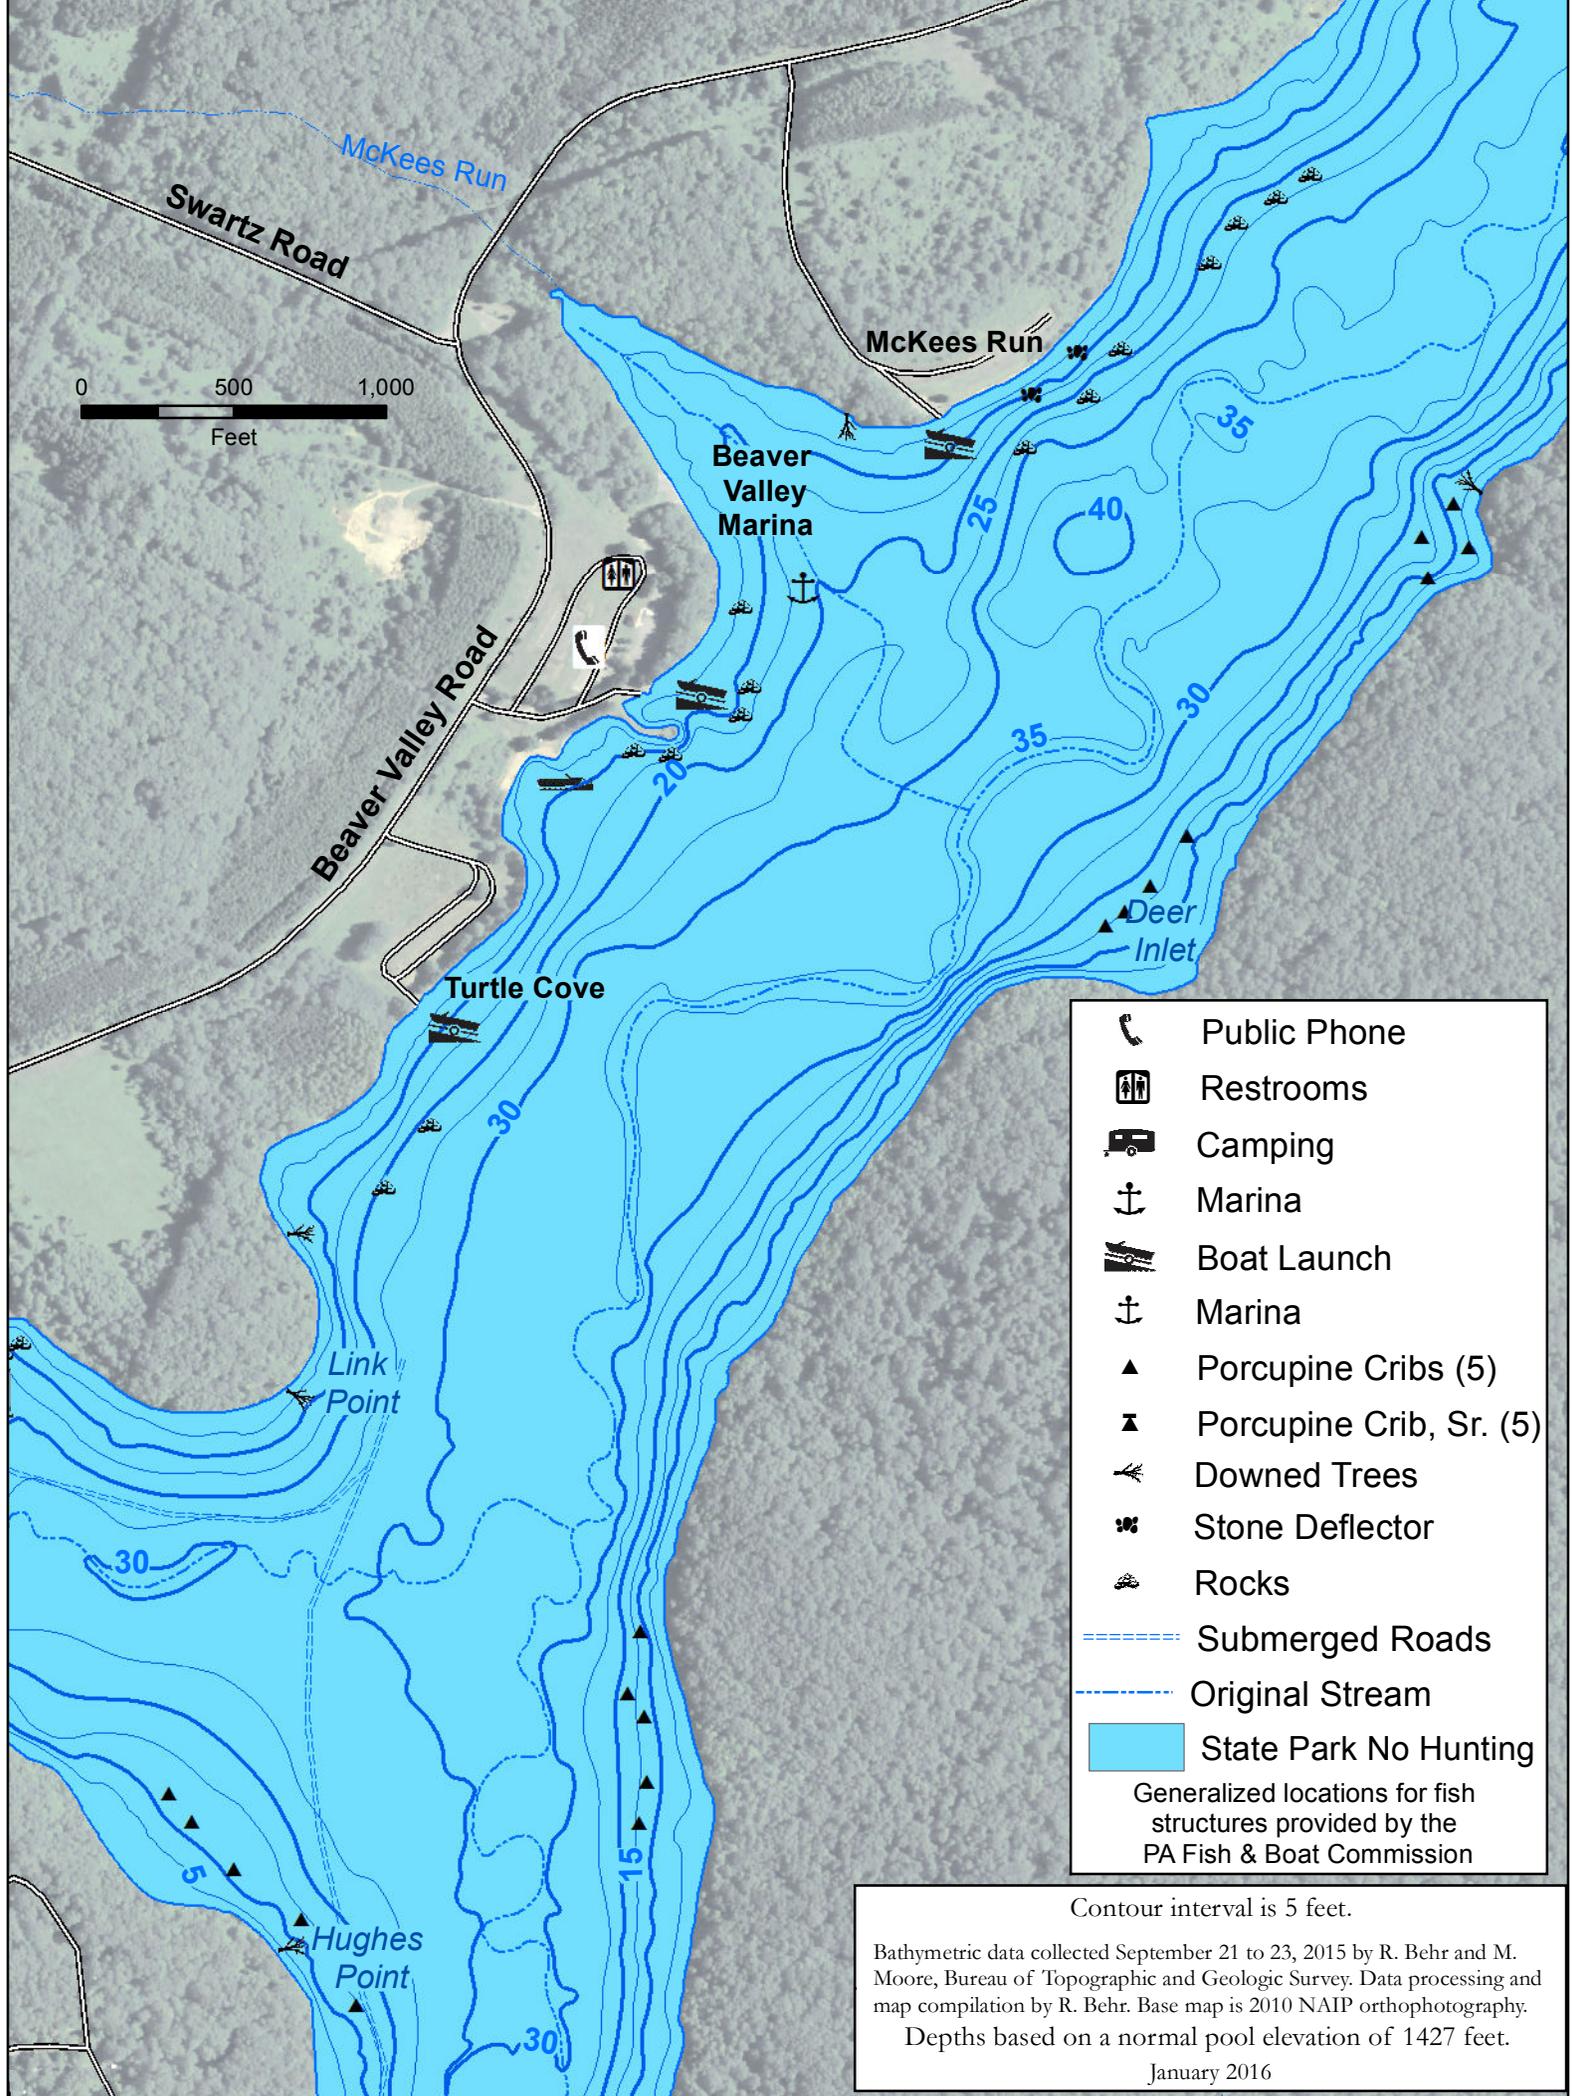
OFMI 16-01.0, Plate 2
 Water Depth of
Beaver Valley
Glendale Lake

Bathymetric data collected September 21 to 23, 2015 by R. Behr and M. Moore, Bureau of Topographic and Geologic Survey. Data processing and map compilation by R. Behr. Base map is 2010 NAIP orthophotography. Depths based on a normal pool elevation of 1427 feet.

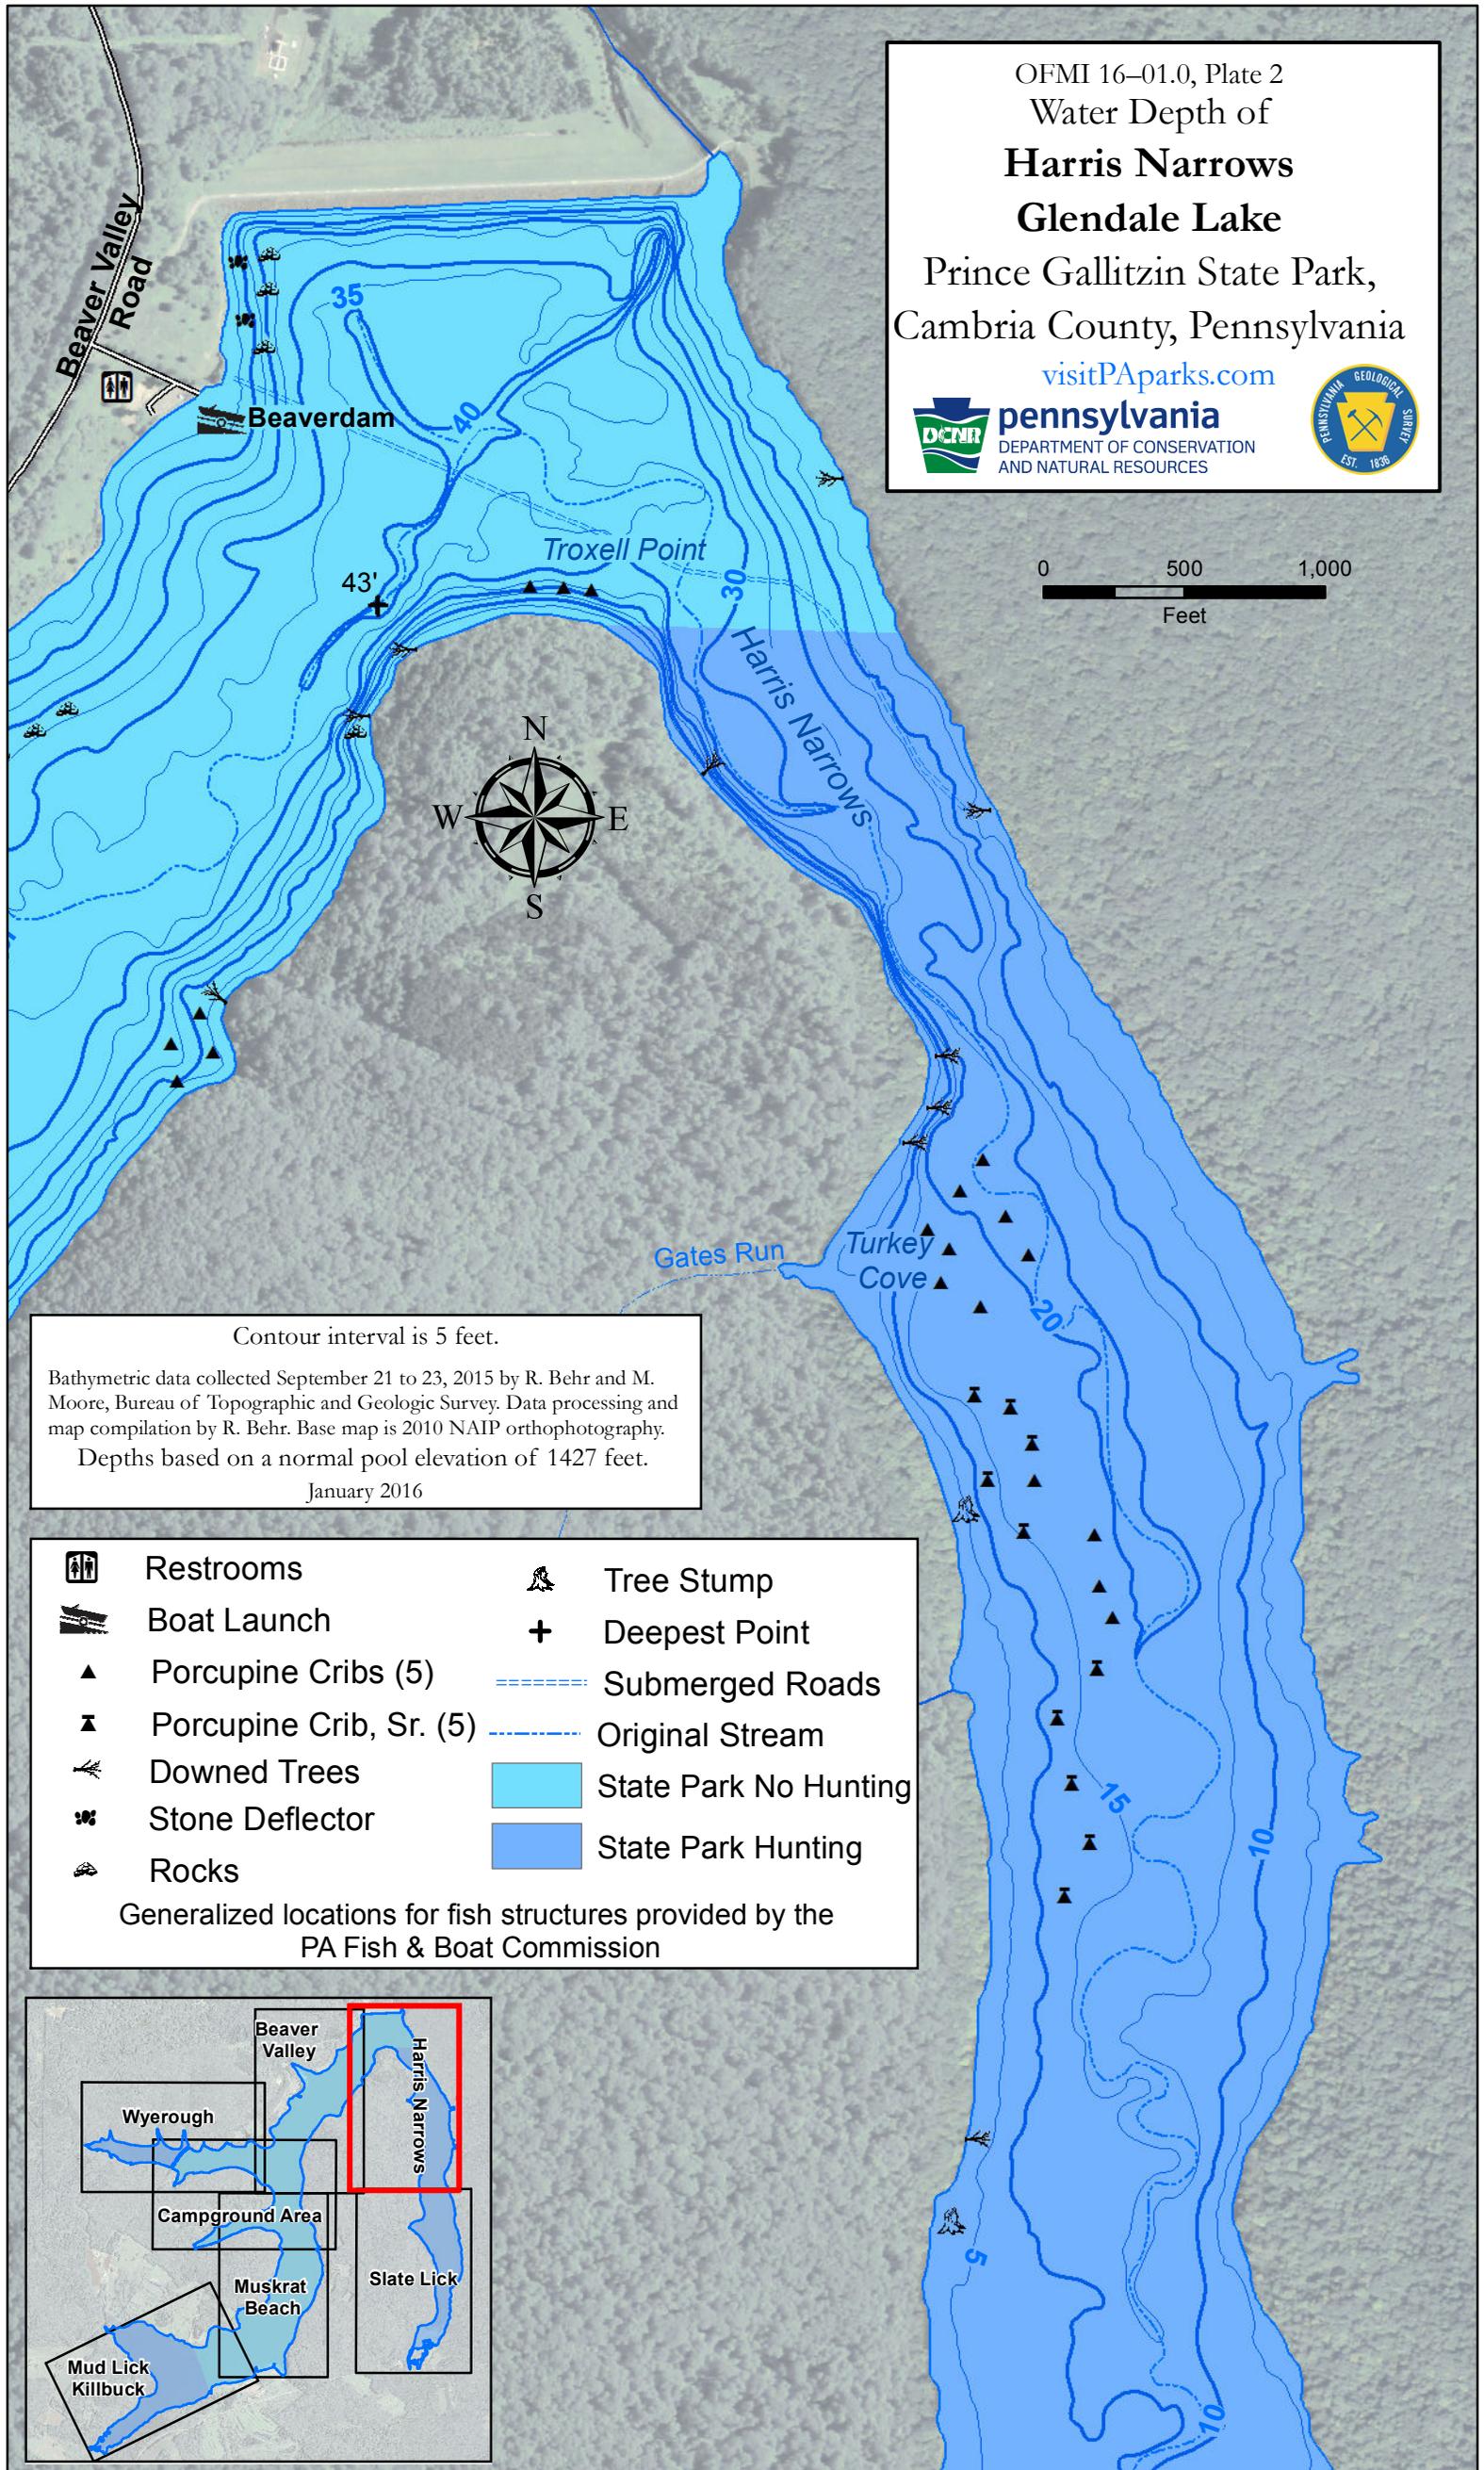
OFMI 16-01.0, Plate 2
 Water Depth of
Harris Narrows
Glendale Lake

Contour interval is 5 feet.
 Bathymetric data collected September 21 to 23, 2015 by R. Behr and M. Moore, Bureau of Topographic and Geologic Survey. Data processing and map compilation by R. Behr. Base map is 2010 NAIP orthophotography.
 Depths based on a normal pool elevation of 1427 feet.
 January 2016

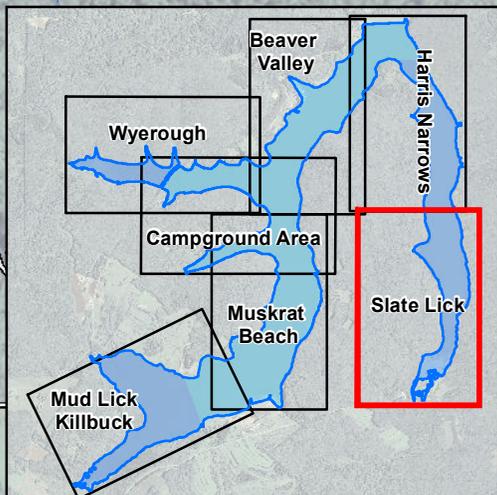
OFMI 16-01.0, Plate 2
 Water Depth of
Slate Lick
Glendale Lake

Bathymetric data collected September 21 to 23, 2015 by R. Behr and M. Moore, Bureau of Topographic and Geologic Survey. Data processing and map compilation by R. Behr. Base map is 2010 NAIP orthophotography.

Depths based on a normal pool elevation of 1427 feet.
